Final Lead-Based Paint Recontamination Study Report

Omaha Lead Site Omaha, Nebraska

February 2009

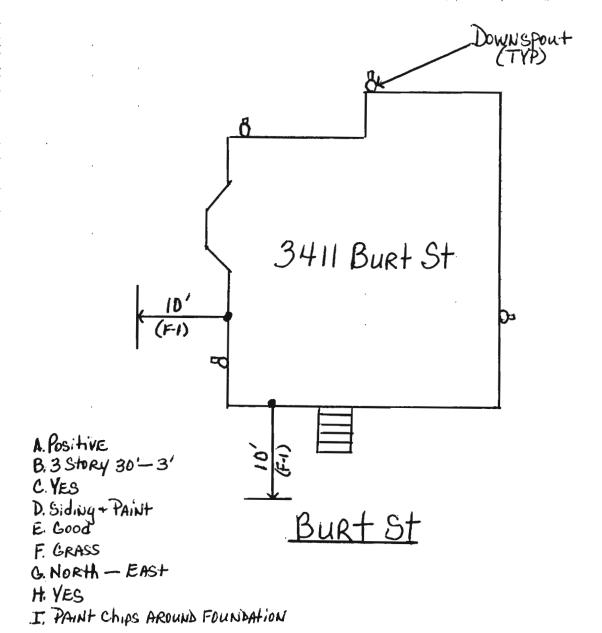
Sampled Address: 3411 BORT ST Site Sketch Phone: Not paint	Sampled Address: 3411 BURT ST	Poor	North Arrow
--	-------------------------------	------	-------------

- Site grading and drainage (positive [away from structure] or negative)
- b. Number of stories, roof overhang (measured if possible) and distance from ground to soffit.
- c. Presence of gutters, location of downspouts and drainage swales.
- d. Exterior finish.
- e. Paint condition and XRF results.
- f. DZ features such as presence of vegetation, mulch, bare ground, visible paint chips, etc.
- g. DZ sample locations and wall orientation (N, S, E, W).
- h. Digital photos will be taken at each DZ sampling location. Additional photos may be taken.
- i. Other observations that could impact the potential for elevated soil lead concentrations in drip zones to develop.

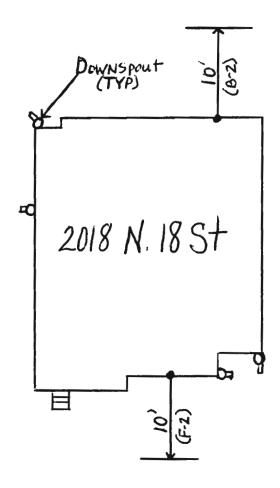
- e. Paint condition and XRF results.
- f. DZ features such as presence of vegetation, mulch, bare ground, visible paint chips, etc.
- g. DZ sample locations and wall orientation (N, S, E, W).
- h. Digital photos will be taken at each DZ sampling location. Additional photos may be taken.
- i. Other observations that could impact the potential for elevated soil lead concentrations in drip zones to develop.

A Fositive B 2 Story 20'-2'

C. YES D. PAINT
